# Inspection Report

38 Forest Knoll Dr  
Weaverville NC 28787

Cameron Home Inspections LLC

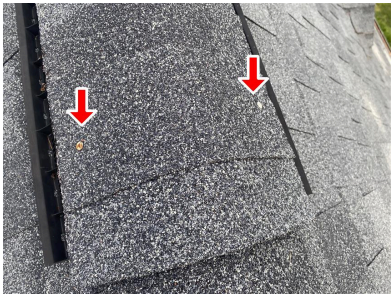
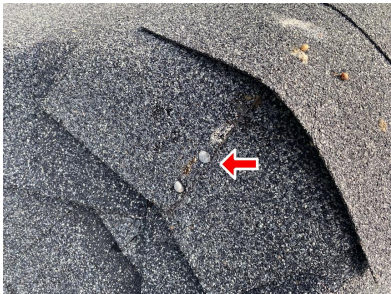
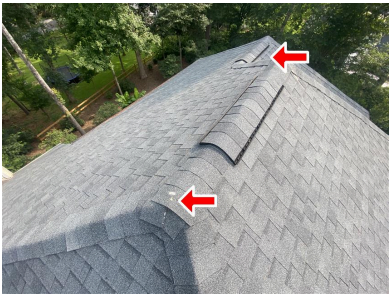
1.0 Item 1 (Picture)

Some of the nail heads on the roof shingles along the ridge caps are exposed and need to be sealed with caulking or roofing tar. Failure to repair may lead to a roof leak. A qualified person should repair as needed.

Some of the nail heads on the roof shingles along the ridge caps are exposed and need to be sealed with caulking or roofing tar. Failure to repair may lead to a roof leak. A qualified person should repair as needed.

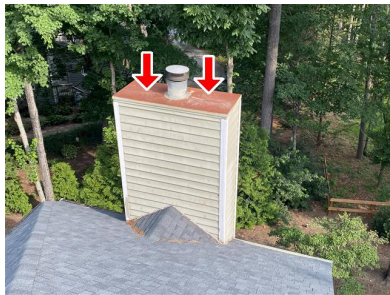
1.2 Item 1 (Picture)

The chimney metal crown has rust signs and may be in need of repair. Failure to repair will allow water to enter and shorten the life span of the chimney. Sometimes a coat of metal paint is all that is needed. A qualified chimney contractor should inspect further and repair or replace as needed.

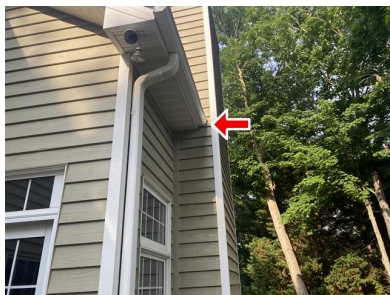
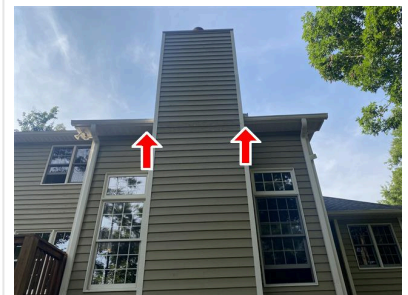
1.3 Item 1 (Picture)

- 🏠 (1) The gutter system is installed incorrectly at the rear of the home in one area and at the chimney chase. There should be a 1 inch gap between the gutter end cap and the siding, and kickout flashing should be installed to divert water away from the siding. Failure to repair may lead to deterioration of siding or water intrusion into the home. A qualified contractor should perform the work.

There should be a 1 inch gap between the gutter end cap and the siding, and kickout flashing should be installed to divert water away from the siding. Failure to repair may lead to deterioration of siding or water intrusion into the home. A qualified contractor should perform the work.

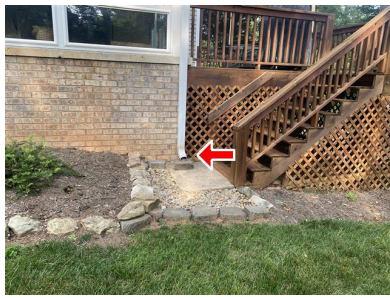
**1.3 Item 4 (Picture)**

- 🏠 (2) Downspout is missing a buried drainpipe at the rear right corner of the home. Buried drainpipes should carry roof rain water away from the home at least 10 feet. Failure to repair may allow erosion or water penetration into the crawlspace. Repairs are needed by a qualified contractor.

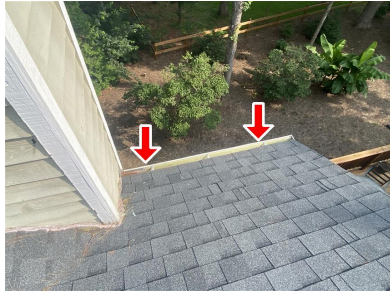
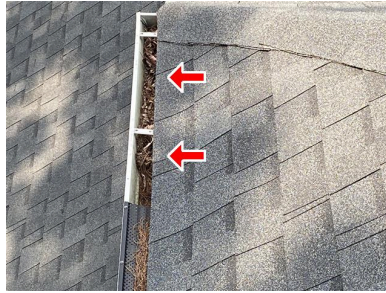
**1.3 Item 6 (Picture)**

- 🏠 (3) The gutter screens are missing next to the chimney and right side (facing front). If gutter screens are not properly in place leaves can contribute to a clog which can cause deterioration of fascia, soffit or roof edge. It can also cause gutters to pull loose and lead to possible water intrusion. A qualified person should repair as needed.

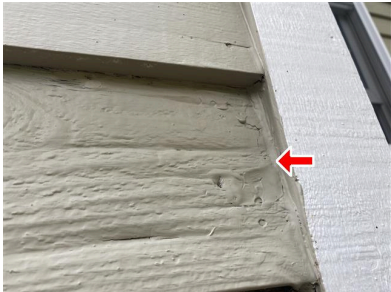
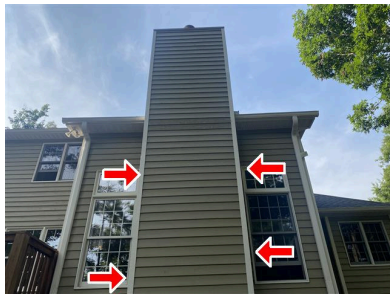
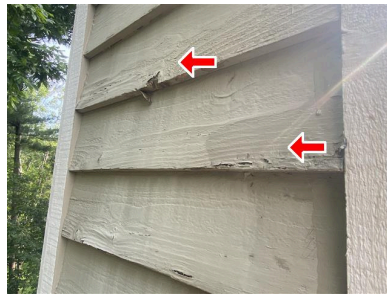
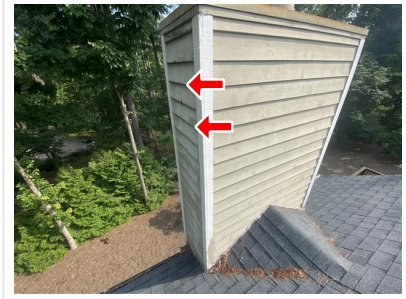
2.0 Item 1 (Picture)

- 🏠 (1) The wood siding and trim at the chimney chase is deteriorated in several areas. Further deterioration can occur if not corrected. A qualified contractor should inspect and repair as needed.

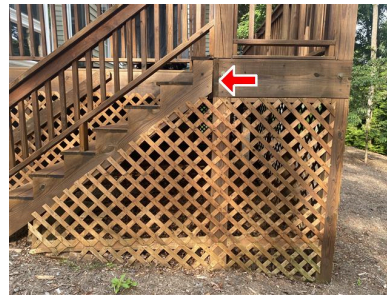
2.3 Item 1 (Picture)

- 🏠 (1) The stair stingers have nails pulling away from the band joist at the top of the rear deck. Adding joist hangers should ensure stability. A qualified person should perform the work.

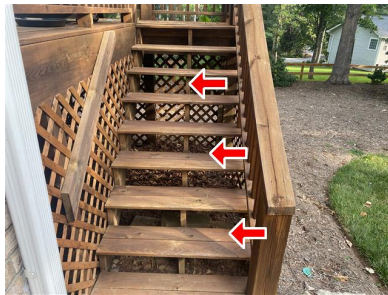
2.3 Item 3 (Picture)

- 🏠 (2) The stairs under the deck at the rear of the home are missing risers. A fall or injury could occur if not corrected. A qualified contractor should repair as needed.

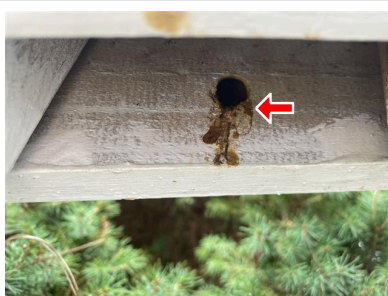
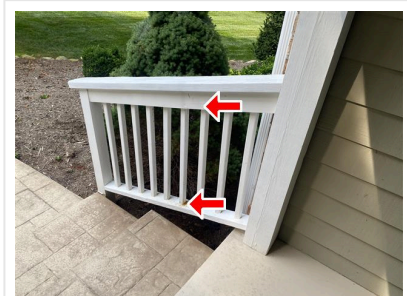
2.3 Item 4 (Picture)

- 🏠 (3) The guardrail on the front porch is slightly damaged (small carpenter bee damage). Further deterioration can occur if not repaired. A qualified person should perform the work.

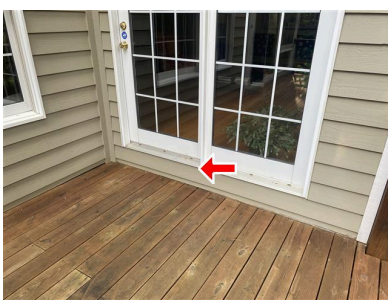
2.3 Item 8 (Picture)

- 🏠 (5) The deck was built enough below the living room sliding glass door to require a step. A fall or injury may occur if not installed. A qualified contractor should perform the work.

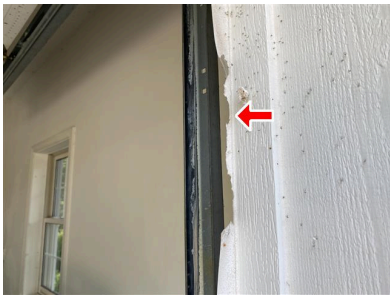
3.3 Item 1 (Picture)

🏠 The garage door reveals daylight where the weather-stripping is damaged a couple small areas. This can cause water or pest intrusion if not corrected. A qualified person should repair as needed.

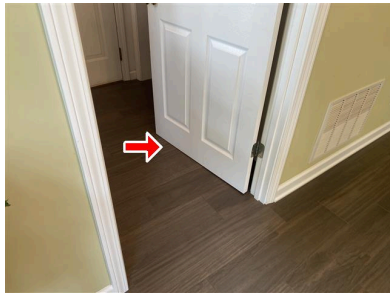
4.5 Item 1 (Picture)

The entry door rubs at floor when closing at the laundry room. A repair or adjustment is needed. A qualified person should repair as needed.

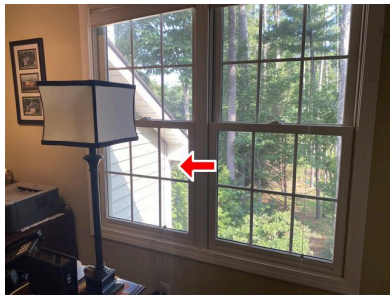
4.6 Item 1 (Picture)

(1) One window will not stay up without a prop at the upstairs office. Repairs are needed. A qualified contractor should inspect and repair as needed.

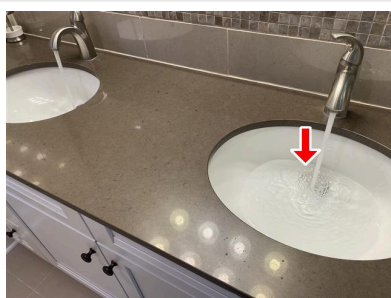
6.2 Item 1 (Picture)

- 🏠 The plumbing waste line drains slowly which may be partially clogged at the downstairs guest bathroom sink on the right. Repairs are needed. A qualified person should repair as necessary.

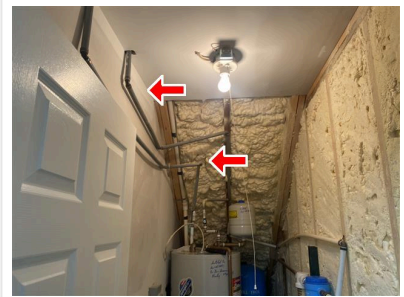
6.3 Item 1 (Picture)

- 🏠 (1) Polybutylene plastic plumbing supply lines (PB) are installed in the basement utility closet above the water heater and under the kitchen sink and some of the bathrooms. Polybutylene has been used in this area for many years, but has had a higher than normal failure rate, and is no longer being widely used. Copper and Brass fittings used in later years (copper used on this house) have apparently reduced the failure rate. Although there were no leaks, a licensed plumber should inspect these areas to determine if any

repairs are necessary at this time.

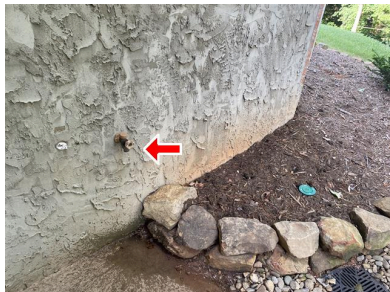
6.3 Item 5 (Picture)

(2) The outside water faucet is loose (missing screws), and needs securing to wall at the rear of the home. This is a small repair. A qualified person should repair as necessary.

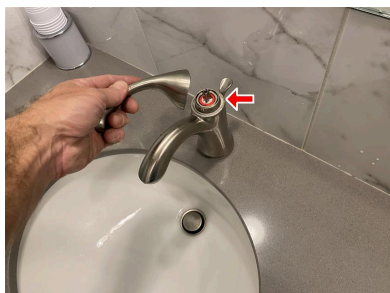
6.3 Item 6 (Picture)

(3) The sink faucet handle on the left is loose (missing screw) at the upstairs bathroom. Repairing this problem now may prevent a future leak. A qualified person should repair as necessary.

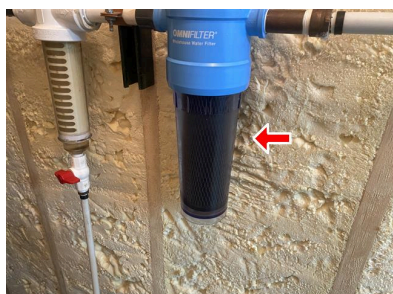
6.3 Item 7 (Picture)

(4) The water filter is very dirty which indicates the filter needs to be changed. Failure to replace dirty filters can lead to lower water pressure, leaks, as well as other costly repairs. A qualified person should replace as needed.

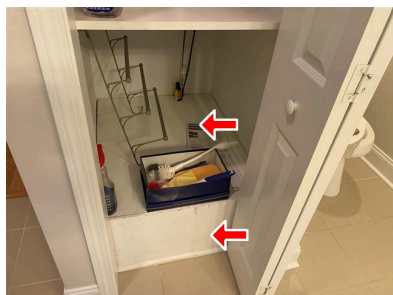
6.5 Item 1 (Picture)

I was unable to visually inspect the ejector pump due to wood paneling screwed shut around it in the downstairs bathroom closet. No leaks were detected at the surrounding areas and it appeared to be working properly during inspection. This is for your information.

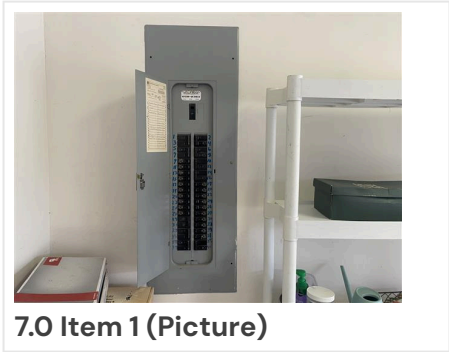
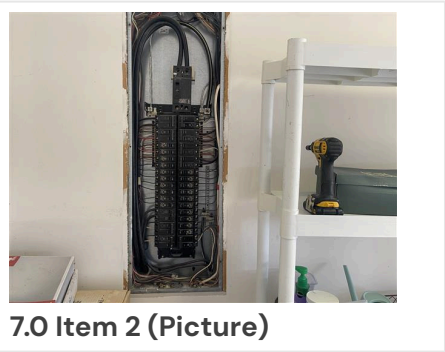
(1) The main panel box is located at the garage. This is for your information.

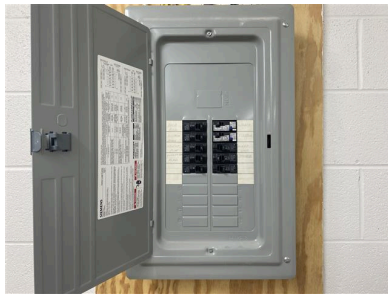
7.0 Item 3 (Picture)

(2) The sub panel box is located at the basement.

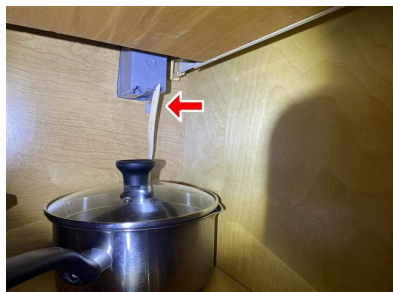
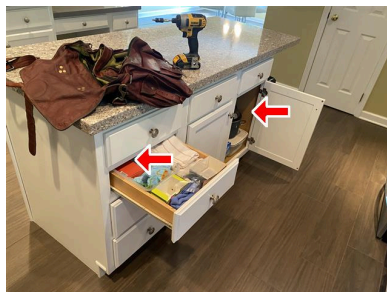
7.3 Item 1 (Picture)

There are conductors exposed inside the kitchen island. These conductors are susceptible to damage. All electrical conductors must be concealed behind finished spaces or installed inside of protective conduit. All electrical repairs are hazardous until fixed. I recommend repair by a licensed electrician.

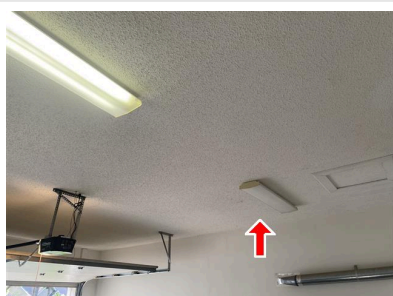
7.4 Item 1 (Picture)

(2) One of the fluorescent light fixtures does not work (try replacing bulb first) at the garage. This is for your information. I recommend repair as needed.

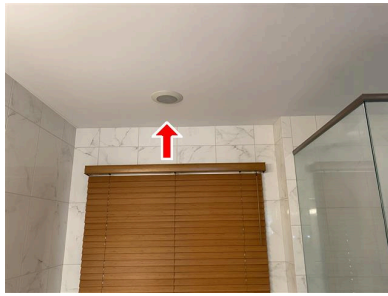
7.4 Item 2 (Picture)

- 🏠 (3) The light fixture does not work (try replacing bulb first) at the master bathroom above the tub area. This is for your information. I recommend repair as needed.

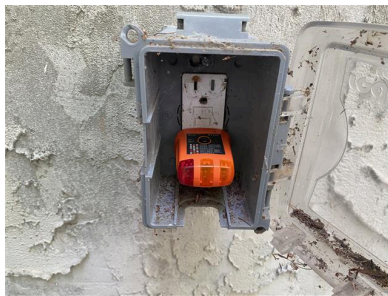
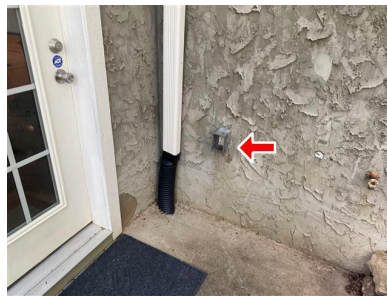
7.5 Item 1 (Picture)

- 🏠 (1) One GFCI (Ground Fault Circuit Interrupter) outlet at the rear of the home did not work (possible defective outlet) or there is no power to outlet. Electrical issues are considered a hazard until repaired. I recommend repair as needed.

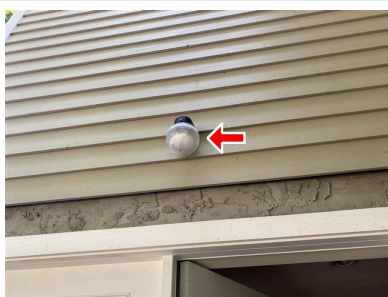
7.5 Item 3 (Picture)

- 🏠 (2) The exterior light fixture does not work (try replacing bulb first) above the basement side entry door. This is for your information. I recommend repair as needed.

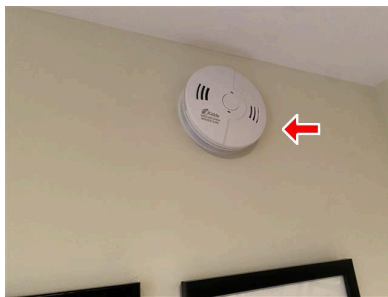
7.8 Item 1 (Picture)

- 🏠 There is no working carbon monoxide detector found in the home (only one in the basement that was not working when tested). It is recommended that one be installed on each floor according to the manufacturer's instructions.

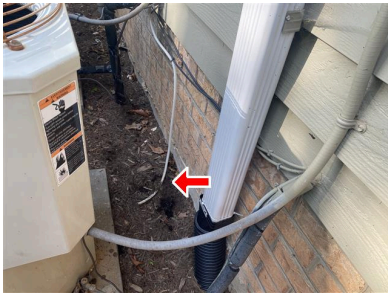
8.4 Item 2 (Picture)

- 🏠 (2) The condensation pipe for the main HVAC system is not extended to an approved distance from the foundation. This pipe is allowing moisture to reach the foundation wall. Have a qualified contractor extend this pipe to an approved distance.

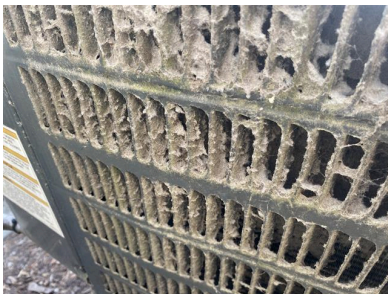
8.4 Item 4 (Picture)

- 🏠 (4) The metal fins on the condenser unit (main unit) outside are clogged in areas due to excessive dryer lint blowing on it. This restricts proper air flow when in operation. A licensed HVAC contractor should inspect further and repair as needed.

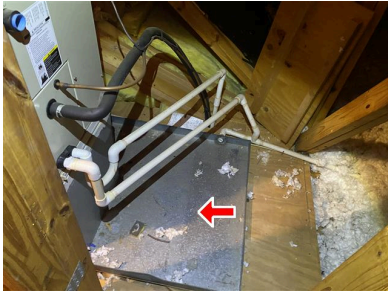
8.4 Item 6 (Picture)

(5) The air handler inside the attic had a drip pan installed under the evaporator but I did not see a sensor installed that would automatically shut the unit off in the case of a leak. Failure to repair would allow damage to surrounding building materials if a leak occurred. The pan is also filled with insulation or other debris which can clog the overflow pan drain in the event of a leak. Repair is needed by a licensed HVAC contractor.

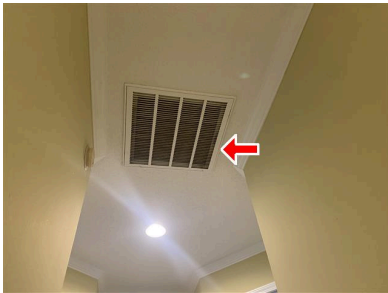
8.4 Item 7 (Picture)

(6) The return air filter for the upstairs unit is located at the upstairs hallway ceiling. The filter is dirty and needs replaced. Check this filter for replacement every 90 days. Failure to keep this filter changed can shorten the life span of the HVAC unit.

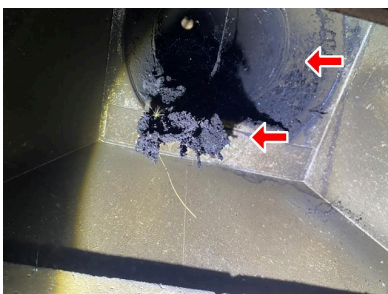
8.6 Item 1 (Picture)

The metal liner in chimney for fireplace at the living room has build-up of creosote (can cause chimney fire). If creosote is not cleaned a chimney or house fire could result. A qualified chimney sweep should inspect and repair as needed.

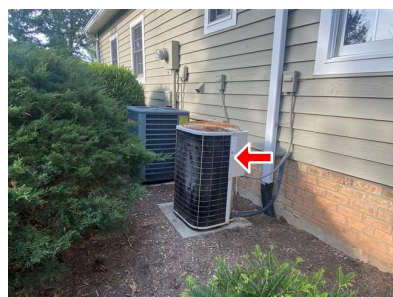
8.8 Item 2 (Picture)

- 🏠 (2) The HVAC system is very old (original, 31 years old) and may last a few years more, but maybe not. I have seen units fail shortly after a home inspection during the seasonal change from mild to hot weather. I cannot determine how long your HVAC system will last before a replacement is necessary. Due to the age of the system I recommend a licensed HVAC contractor inspect further to determine if this system needs replacement.

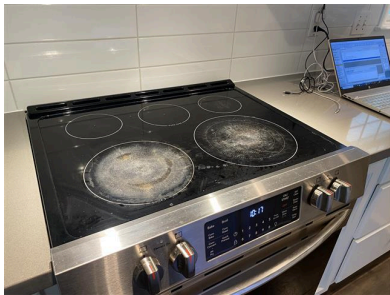
10.1 Item 1 (Picture)

The glass cooktop is scratched and/or stained at the front burners but is still functional. It is not cost effective to replace the glass. This is for your information.
